HISTORIC TALLAHASSEE DESIGN MANUAL

A guide to rehabilitation and new construction
in Tallahassee and Leon County

September 1991

Historic Tallahassee Preservation Board,
Florida Department of State
& Tallahassee-Leon County Architectural Review Board

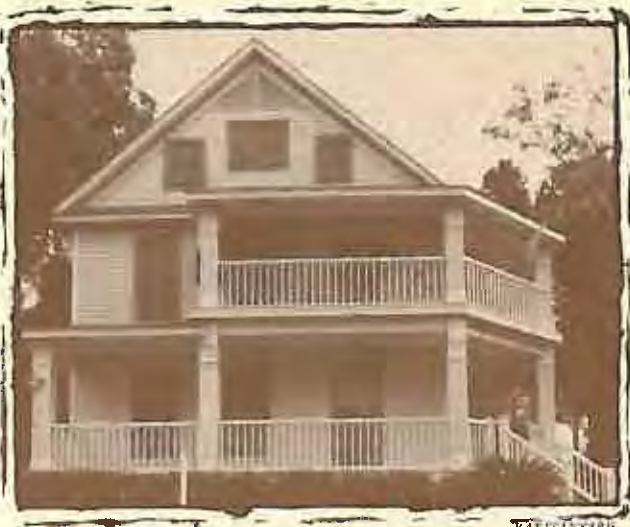
GABLE FRONT
The two story gable front Cotton House is located at 406 North Meridian Street and was built in c. 1904.

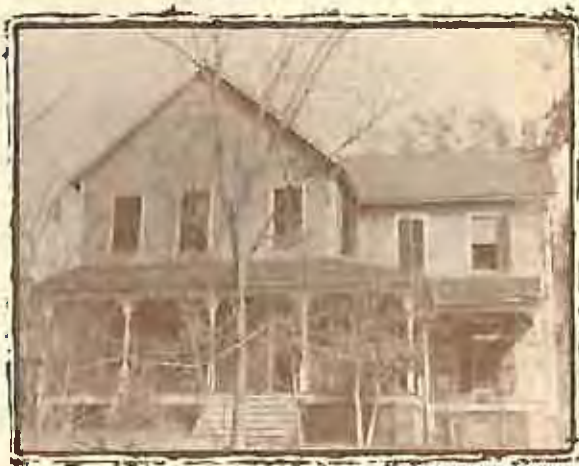
GABLE FRONT AND WING
The c. 1900 Bradford-Wells House at 324 East Virginia Street is an example of a two story gable front and wing house. This photograph shows the house in c. 1922.

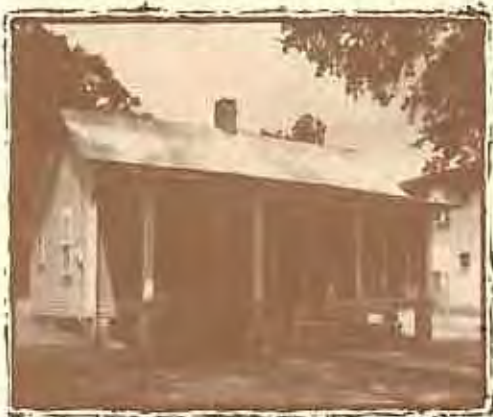
SIDE GABLE
Built in c. 1910, this house at 444 West Carolina Street is an example of the one story side gable vernacular house. Note the similarity to Comte de Castelnau's 1838 illustration on page 5.

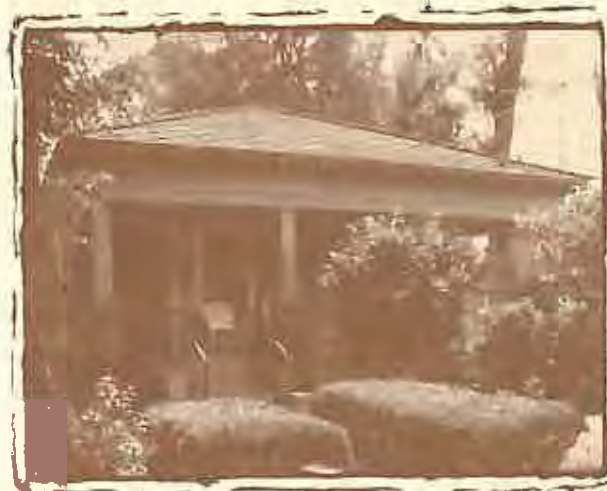
The house at 315 West Call Street was built in 1935 and is a pyramidal roof building with Craftsman influence.

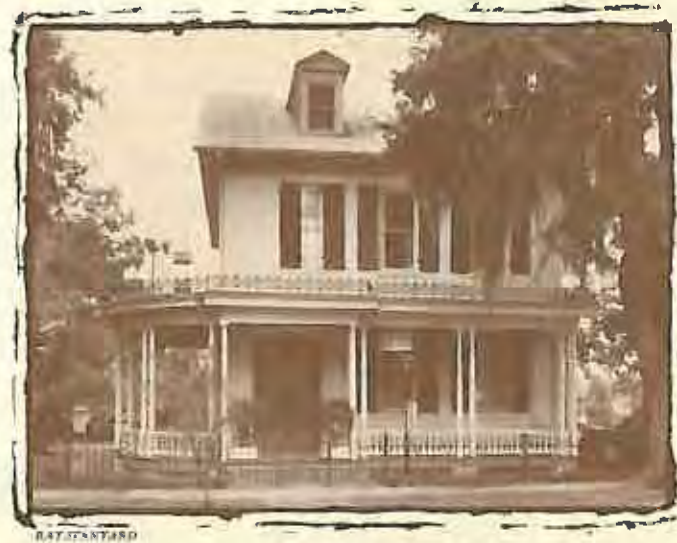
FEDERAL
The 1844 Bloxham House at 410 North Calhoun Street, is Tallahassee's finest remaining residential example of the Federal style. The porch is not typical of this style, and was probably added at a later date.

By the 1970s, the Bloxham House at 410 North Calhoun Street was in a serious state of deterioration, and had lost a great deal of its historic character. Note the wing to the left.

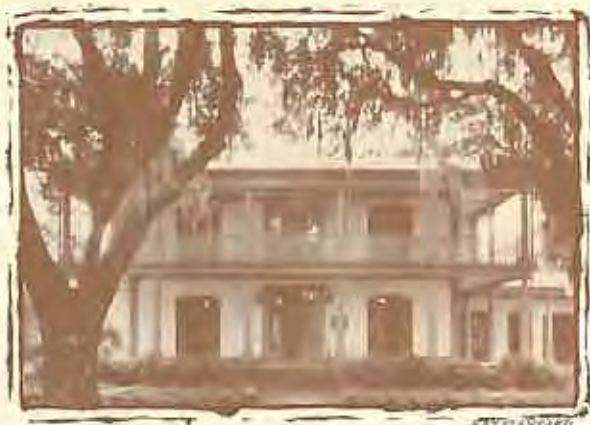
The 1841 Bowen House at 325 North Calhoun Street, is symmetrical in form, has a trabeated doorway with transoms and sidelights, and uses classical columns.

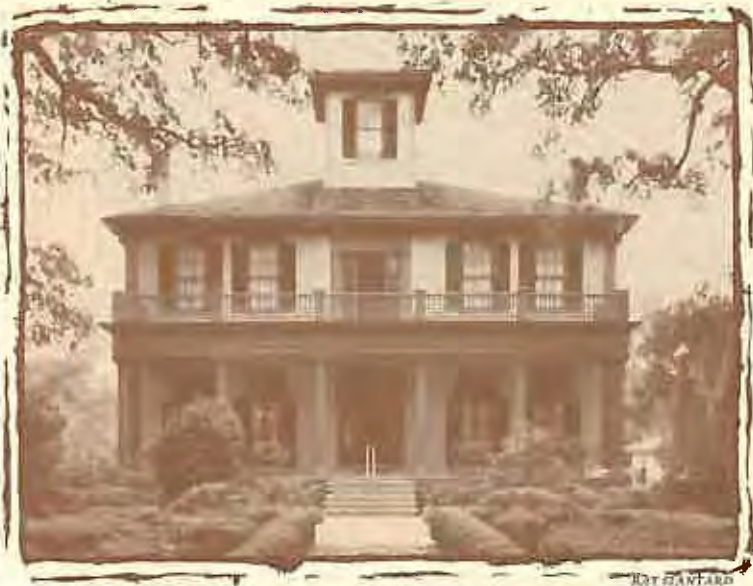
The c. 1856 Brokaw-McDougall House at 329 North Meridian Street was built during the peak of popularity of the Italianate style in America. It has many characteristics of "high style" Italianate architecture, including a "lantern," overhanging eaves with brackets, and low pitched roof.

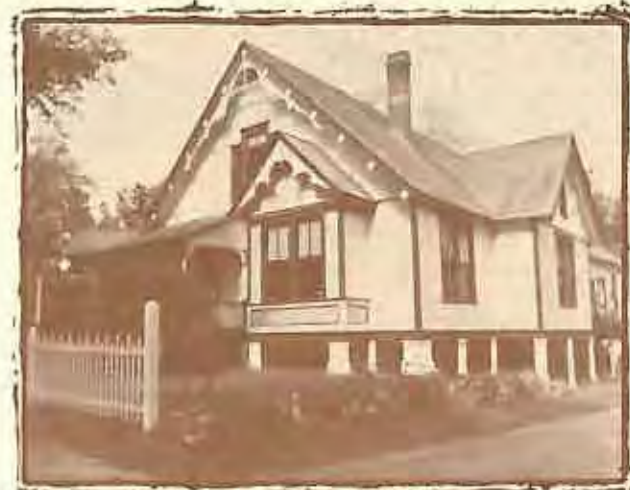
The decorative trim, use of shingles in the gables, and wrap around porch give the 1895 Chesley House at 401 East Virginia Street a strong Queen Anne flavor.

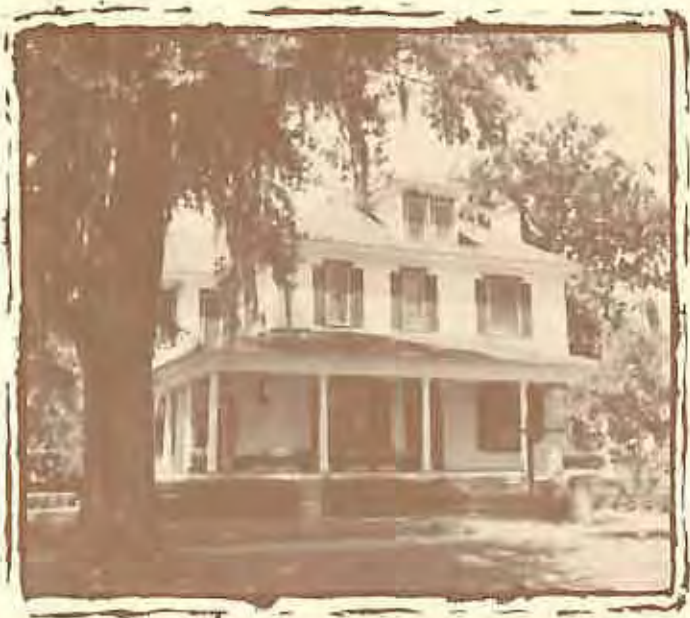
**COLONIAL
REVIVAL**
*Built in 1906 at 318
North Calhoun
Street, the Shine
House is a basic
pyramidal roof house
with Colonial Revival
detailing applied.*

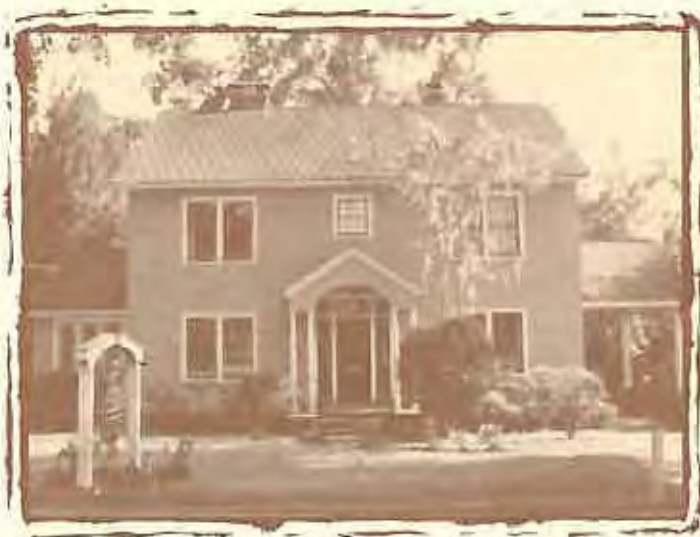
**COLONIAL
REVIVAL**
*The c. 1930 Lee
House at 863 East
Park Avenue is
typical of the more
“academically
correct” later
Colonial Revival
architecture.*

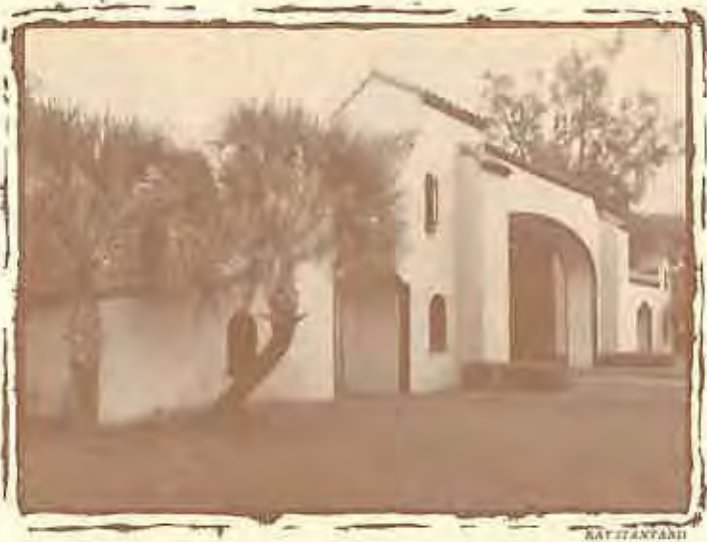
PERIOD REVIVAL
The Los Robles Gate,
with its barrel tile
roof, use of arches,
and stucco finish, is
executed in the
Mediterranean
Revival style. It was
constructed in 1927.

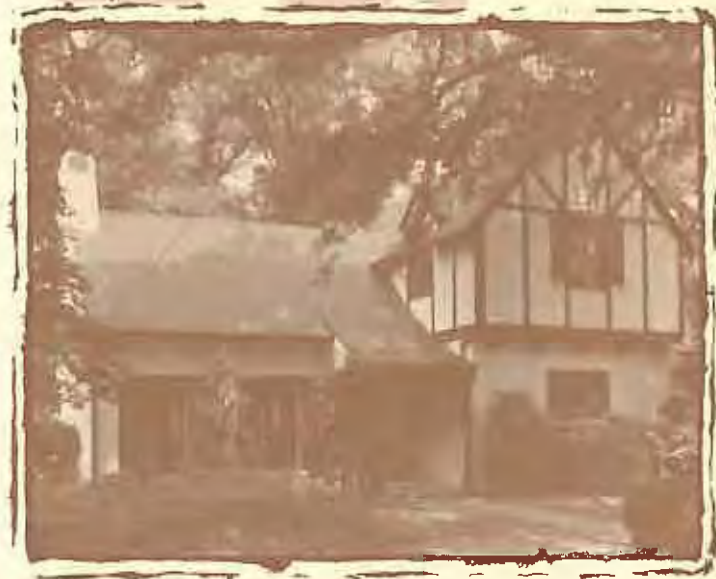
PERIOD REVIVAL
Built in 1927, the
Collin House at 1514
Cristobal Drive, is an
example of Tudor
Revival architecture.
Note the half-
timbering.

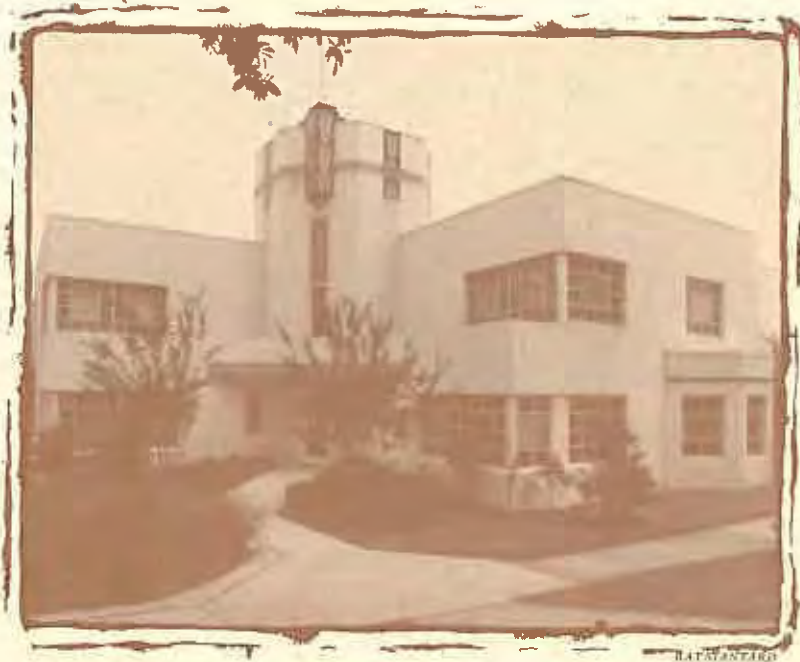
Designed by leading Tampa architect M. Leo Elliott, the 1936 Old Leon County Jail at 803 East Gaines Street is a good example of the Art Deco/Moderne style. Note the streamlined design and the decorative etched glass panels.

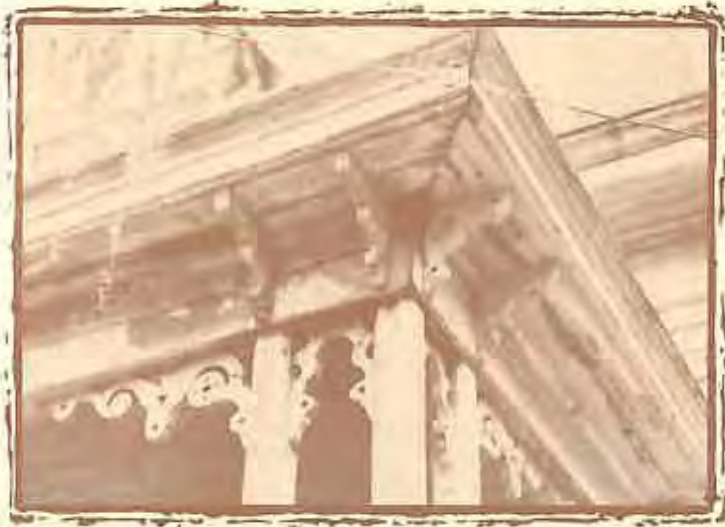
Some problems are very obvious, such as this rotting porch trim.

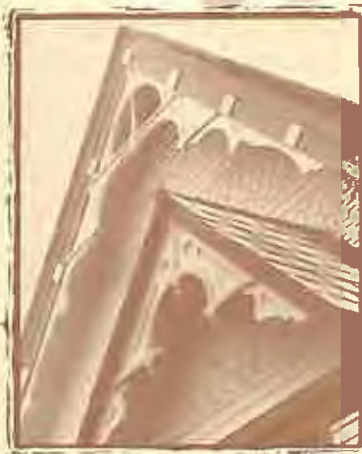
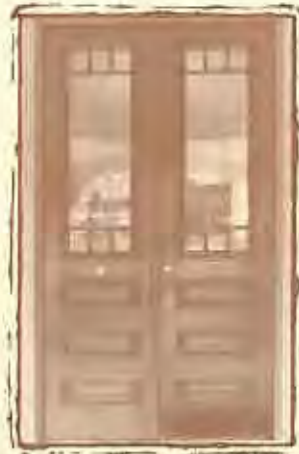
Details on the Chesley House include dominant features such as the fishscale shingles and decorative trim.

Less obvious but also important details are found on the door.

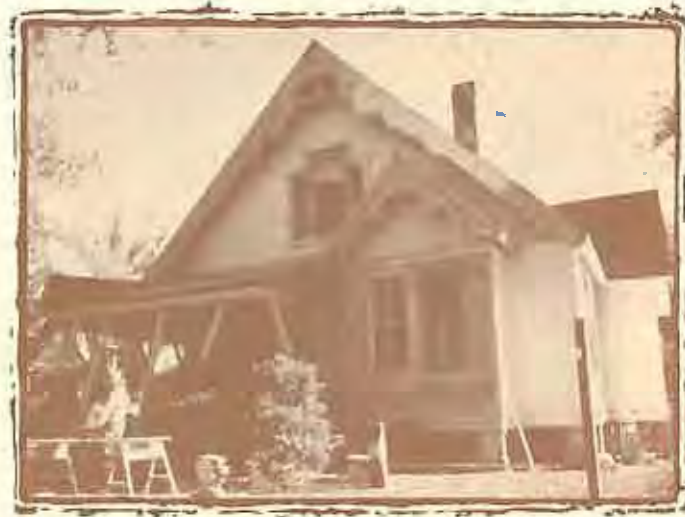
This photograph of the Chesley House during rehabilitation reveals its residential setting, rectangular building form, dominant roof with several gables, projecting porches and bay windows, numerous windows and frame construction.

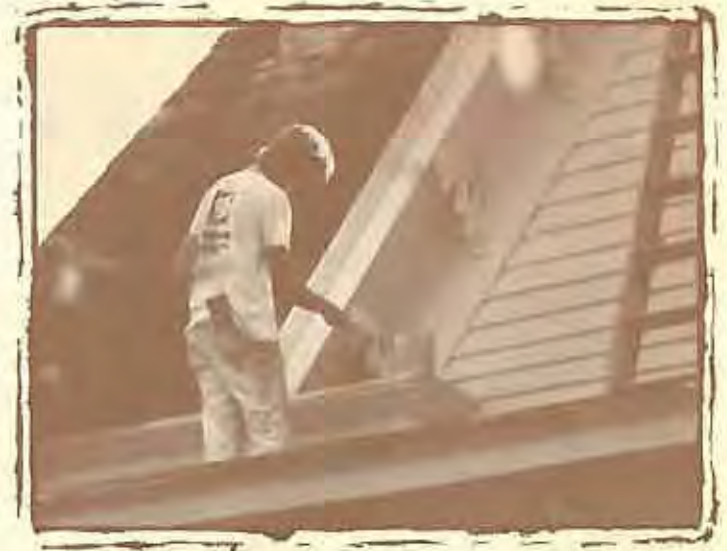
The wooden siding and trim are important character defining features of this building.

This blistering paint indicates moisture damage.

Moisture Damage - Moisture penetration is a serious threat to wood because it can cause decay. In areas with a higher than average humidity level, like Tallahassee, wood is likely to absorb water to the point where decay can begin. **Any** preservation project should repair or replace those features that have been damaged, and ensure that the source of the problem is properly eliminated.

Water damage can be detected through loose, blistered, or peeling paint, warped boards, cracks in the siding, or missing shingles. To discover other problem areas, probe the wood with a small ice pick. If the pick penetrates more than 1/4 of an inch, there may be a problem.

After repairing the damage, make sure the original source of the moisture problem has been eliminated, or the problem will occur again. Typical sources include leaking gutters, downspouts, roofs (especially in valleys and near chimneys), and flashings.

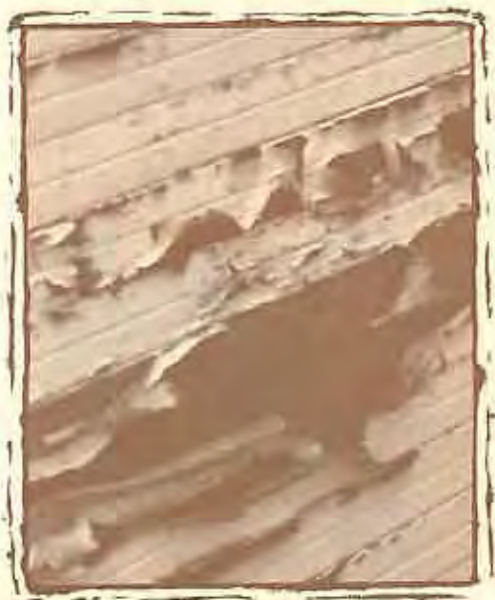
This wood has been infested by termites.

Termite Damage - Signs of termite infestation include seeing small flying insects with wings, piles of wings, and earthen tunnels leading from the soil to the wood. Termite damage may also be present if an ice pick easily penetrates the wood.

involve tenting the building, or treating the soil and wall surfaces below the building with chemicals that attack the termites. Evaluate the various options to find the one that is the least damaging environmentally. Next, remove all infested wood, and replace with pressure treated wood. To prevent further infestation, remove all scrap wood in close proximity to the building, take care to prevent moisture penetration, as termites are attracted to moist wood, and have yearly inspection and treatment by a pest control specialist. The specialist should also be asked to look for signs of beetle and carpenter ant infestation.

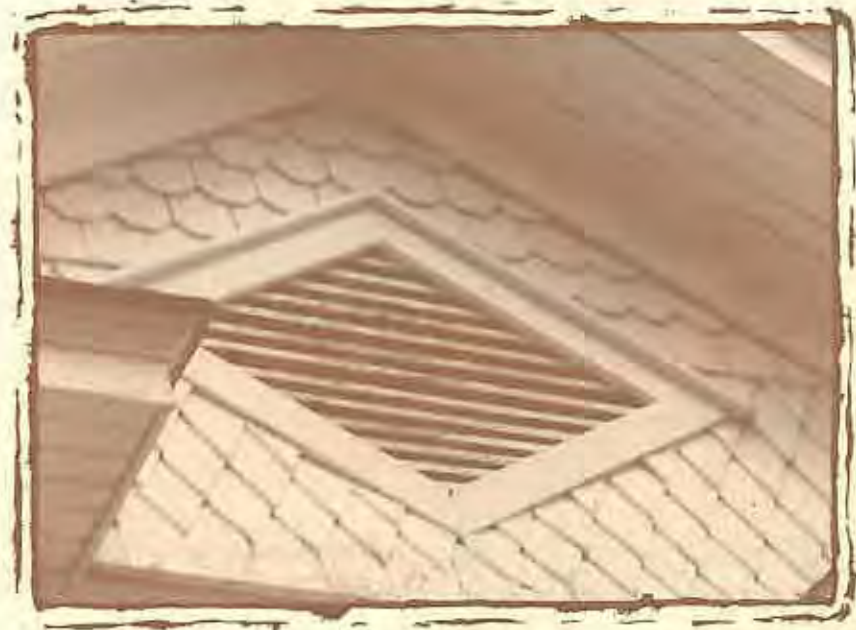
The decorative shingles in this gable end contribute to the character of this building. Damaged shingles should be replaced with new ones of the same shape, texture, and material.

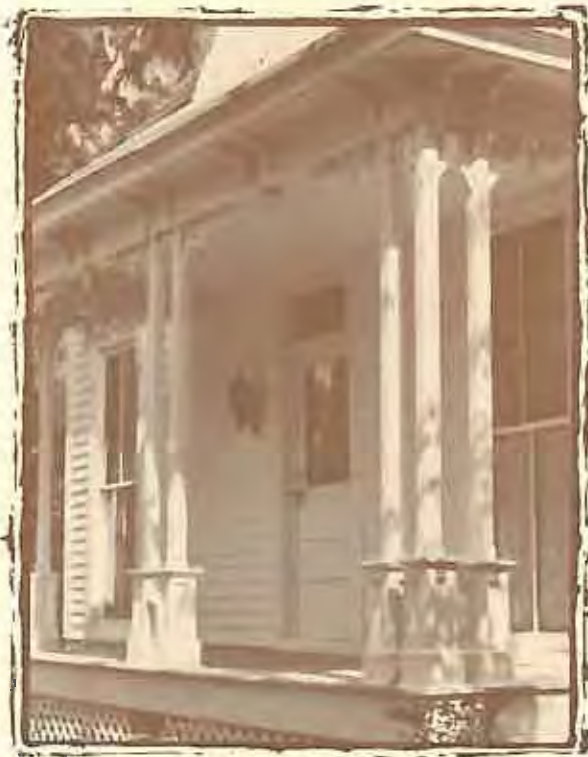
APPROPRIATE

This trim is an important element of the building and has been sensitively repaired.

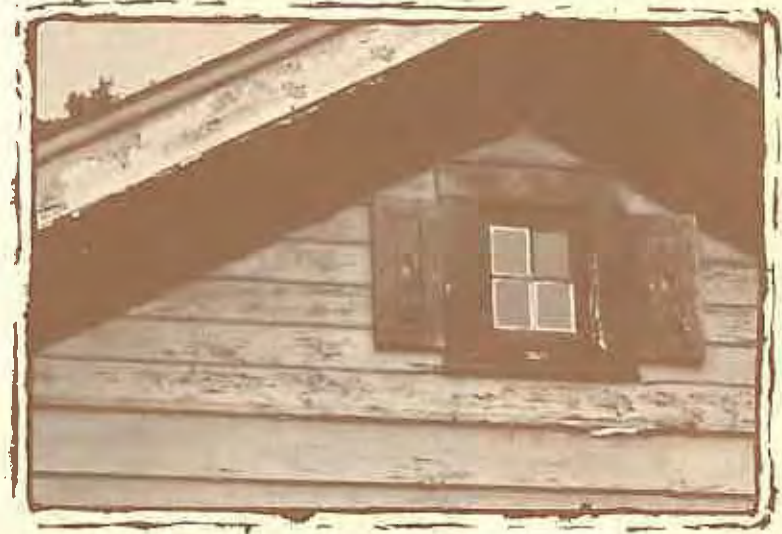
When preparing the building for painting, remove loose and damaged paint.

Removing the Paint - Preparing the building is one of the most important steps for a good paint job. First, loose and damaged paint should be removed. It is not necessary to go down to bare

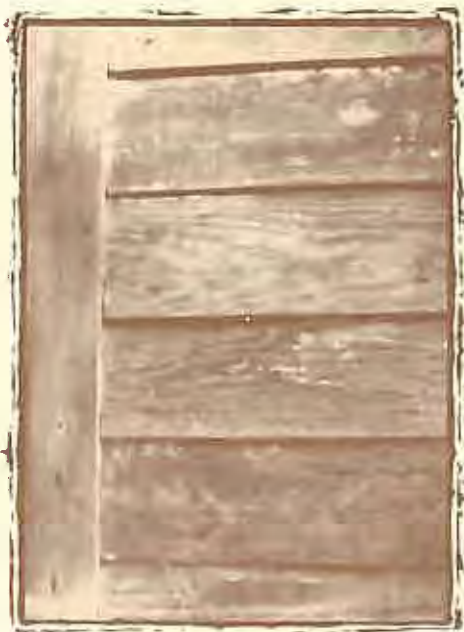
INAPPROPRIATE

This siding was chemically stripped. It seriously damaged the wood by softening it and raising the grain. A few years later the siding had to be replaced.

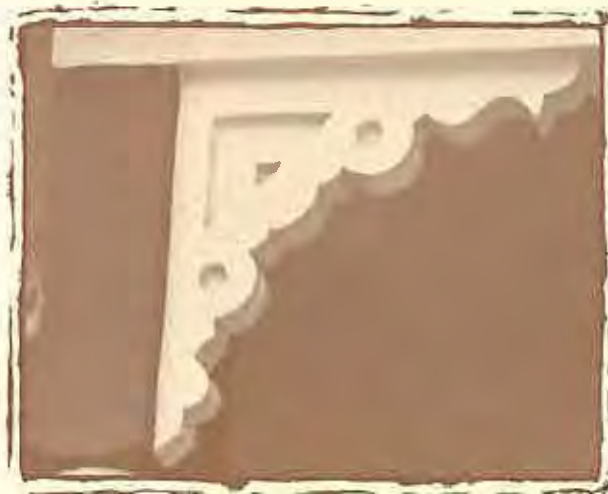
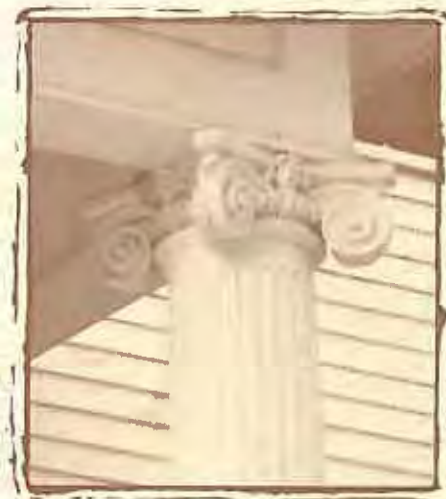
Wooden architectural details such as these are appropriate for careful chemical stripping.

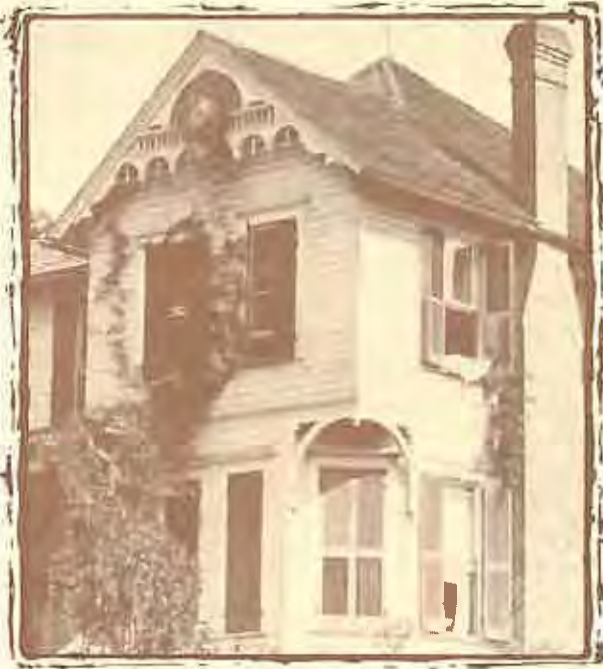
This detail of a historic photograph shows the distinctive character of this building.

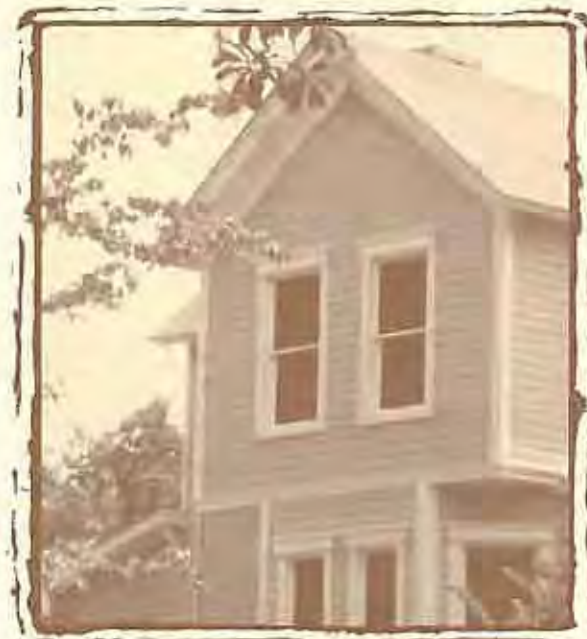
Often, when applying aluminum siding, architectural details are not replaced.

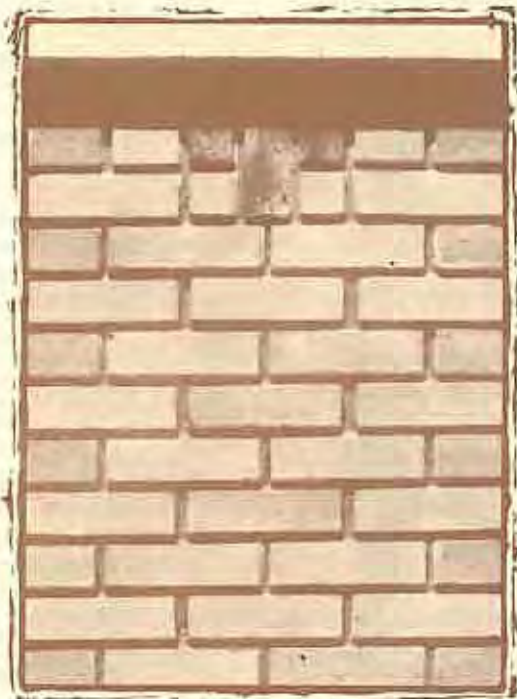
APPROPRIATE
This masonry wall of a Craftsman bungalow shows the original deep joints and unpainted surface.

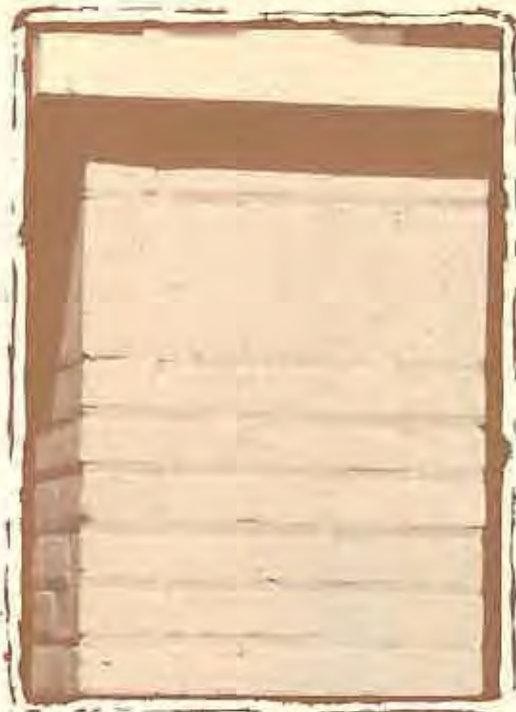
INAPPROPRIATE
This identical wall was incompatibly repointed and painted, a treatment not recommended for originally unpainted historic masonry walls.

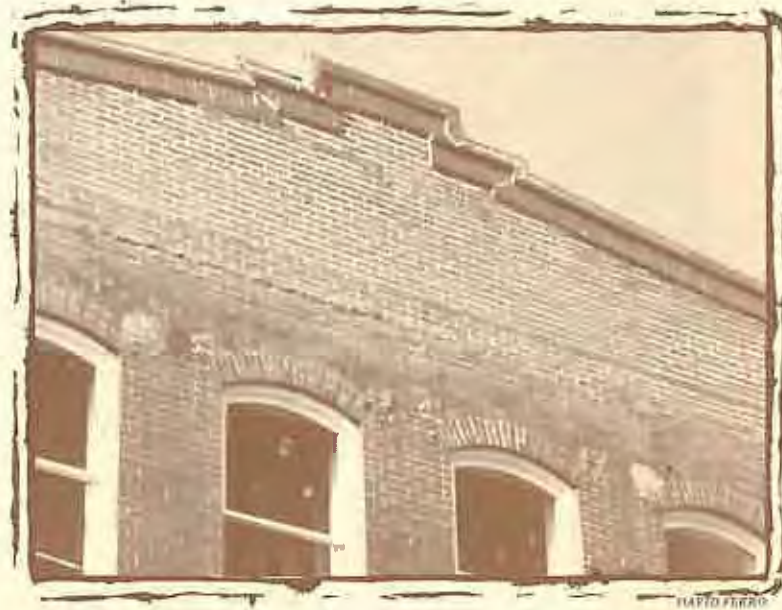
INAPPROPRIATE
This masonry was poorly repointed.

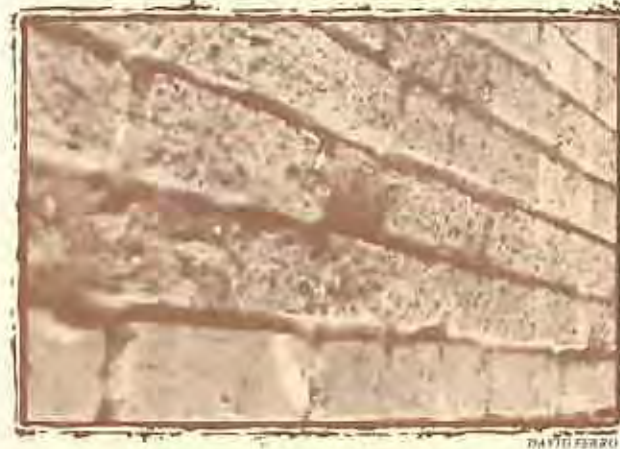
INAPPROPRIATE
Under no condition should brick be sandblasted. Now that it has been damaged, the best option is to paint it to prevent moisture damage.

An acceptable method to clean masonry is with a low pressure water wash. High pressure water (over 600 psi) can result in problems similar to those created by sandblasting.

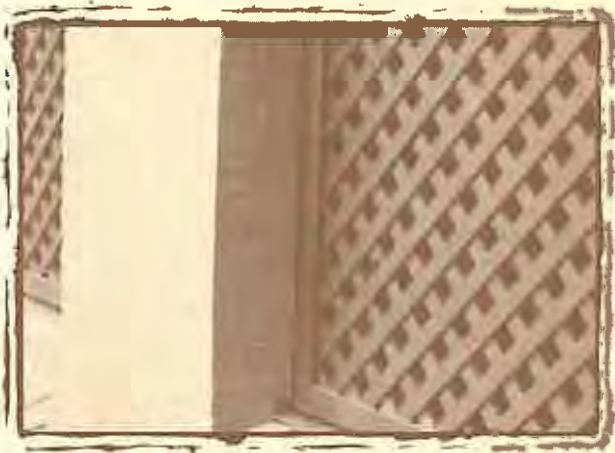
This wooden lattice covers a concrete block foundation with stucco veneer. This is appropriate infill if proper ventilation is provided.

Ventilation is especially important in this climate in order to keep the underside of the building as cool and dry as possible. This discourages insects and retards moisture and decay. Originally, the undersides of many southern houses were open, and wood lattice was used as infill between the piers to screen the crawl space. This provides continuous ventilation to the sub-floor structure and provides ease of access to the crawl space. Wood lattice should be pressure treated and installed a minimum of two inches above the ground. Another alternative is PVC lattice which is rot resistant and can be identical in appearance to wood lattice.

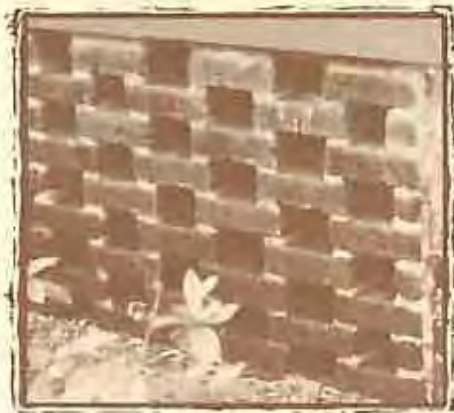
APPROPRIATE

This brick lattice infill is typical on older Tallahassee buildings.

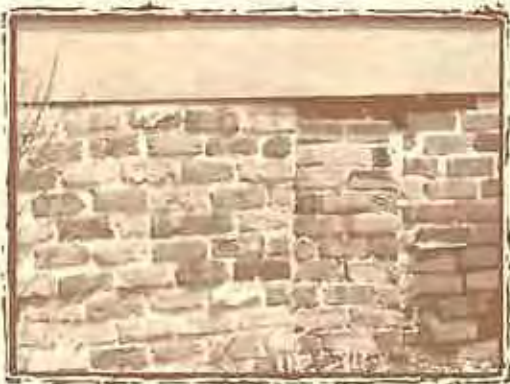
INAPPROPRIATE

The solid brick infill is incompatible from a design perspective.

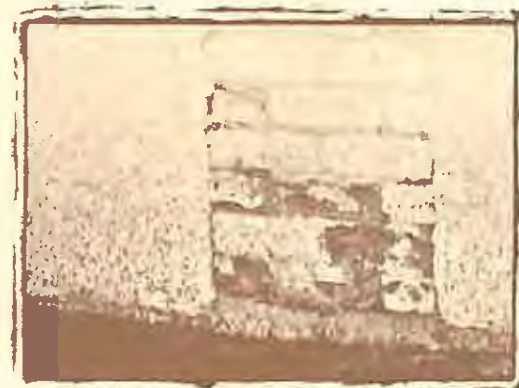
This stuccoed solid infill is inappropriate.

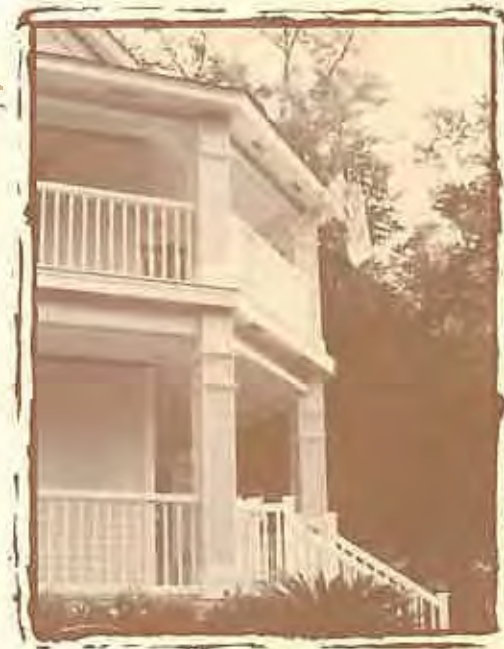
APPROPRIATE
This porch has been reconstructed using historic documentation, and enhances the character of the building.

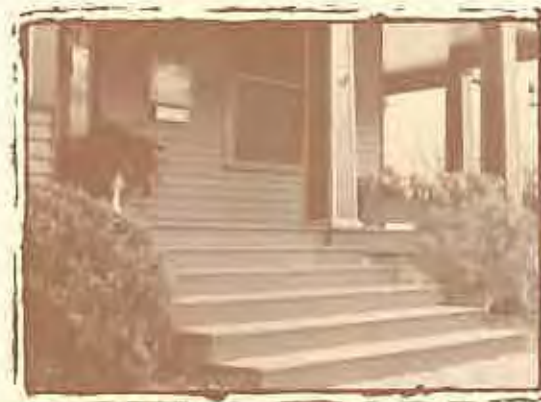
APPROPRIATE
These contemporary wooden porch steps retain the material and character appropriate for this historic building.

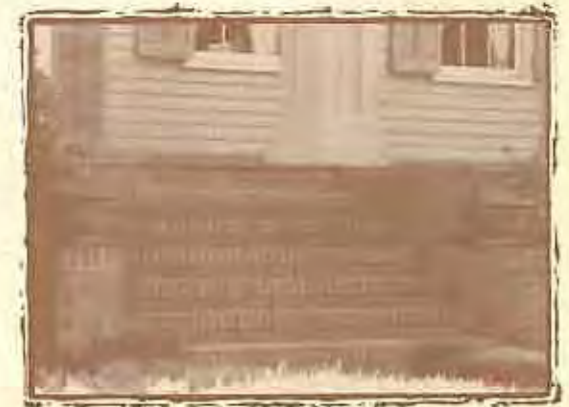
INAPPROPRIATE
These replacement brick front porch steps are too heavy for this frame residence.

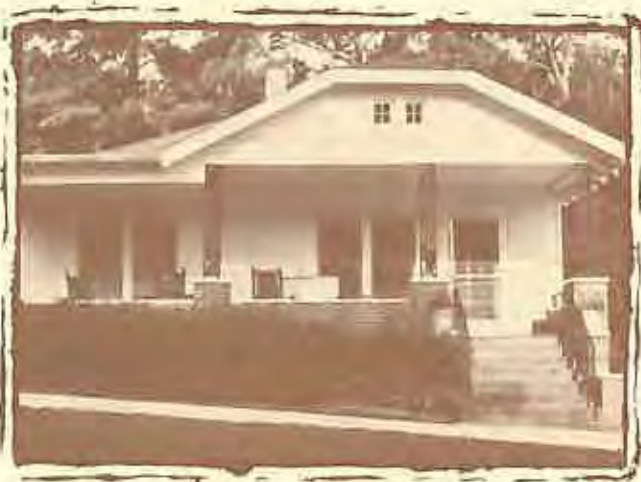
INAPPROPRIATE
The historic columns
have been replaced
with inappropriate
wrought iron supports
which detract from
the character of this
building.

Rails, balustrades and decorative trim should be kept painted and sealed to prevent rot. Since it is often difficult to find exact replacements for these parts, consider repairing them with epoxies, as discussed on page 37. Another alternative to investigate is having the millwork reproduced.

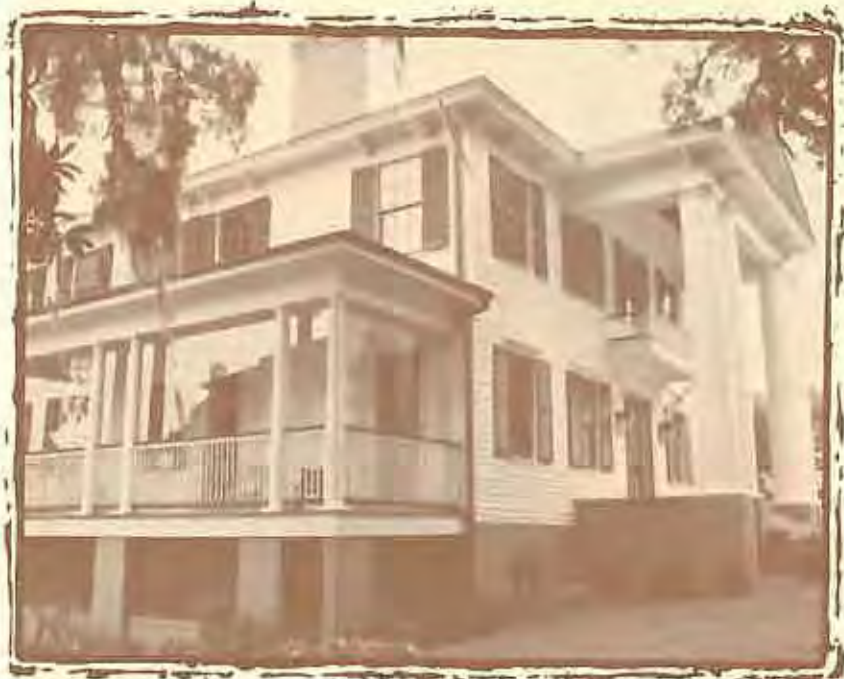
APPROPRIATE
This historic porch on
the Knott House was
sensitively enclosed
with glass.

If the porch is to be enclosed, be as sensitive as possible to the original design of the building. Clear glass and screens may be used to enclose an open porch. Supports for the glass and screens should follow the lines of the structure, and the distinctive porch details should be retained.

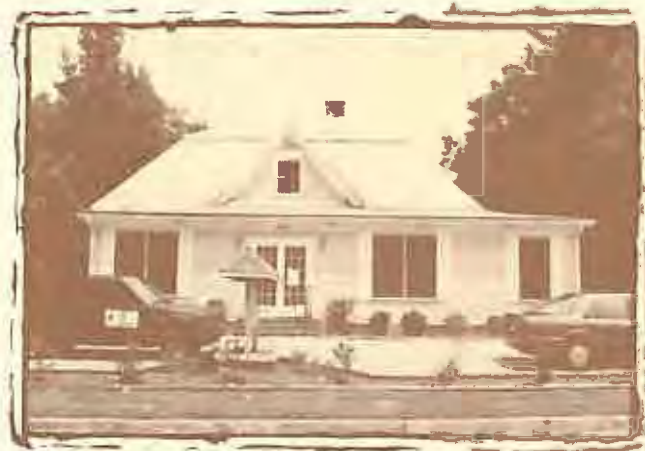
INAPPROPRIATE
This solid infill is an
inappropriate way to
enclose a porch.

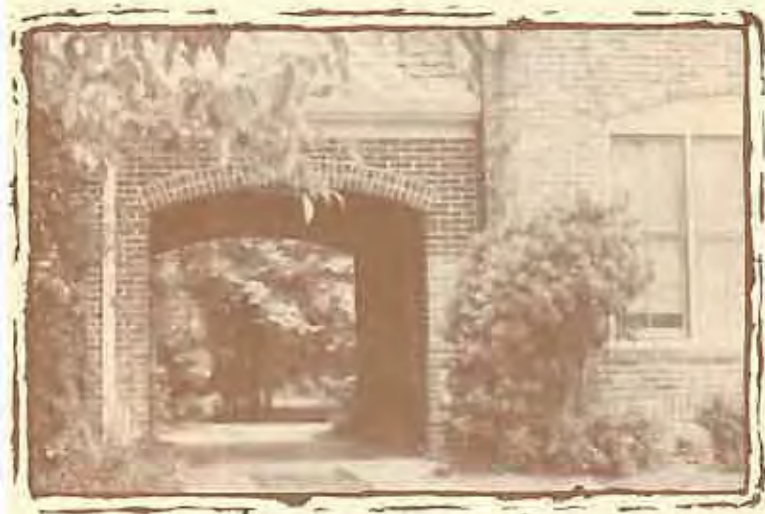
The open character of this porte cochere has been maintained.

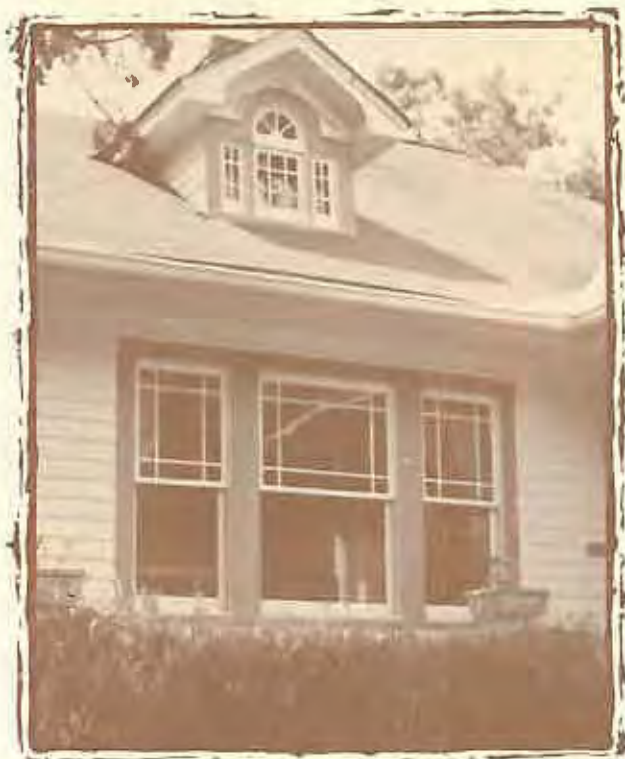
These windows are important character defining features that should be preserved.

Windows are an important character-defining feature of a historic building, and are an element that should be preserved. Historic windows generally should not be replaced with new windows. Historic windows consist of the frame, the sash (or moveable part of the window), and the glazing (window glass).

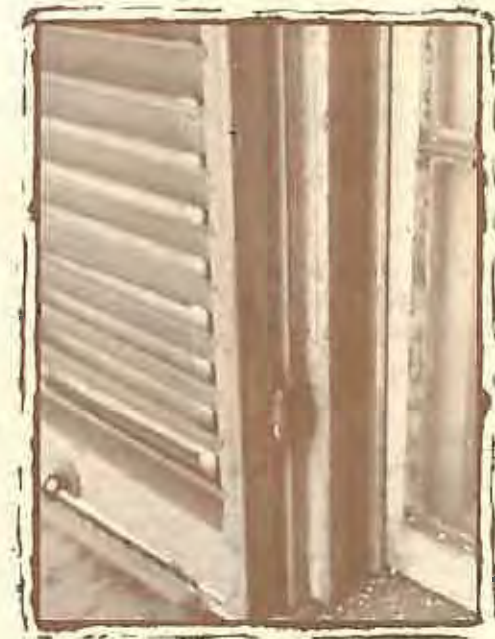
Historic windows are often in disrepair due to the lack of routine maintenance.

Most older sash windows operate on a weight and pulley system which when working properly makes it easy to open the window, and ensures that the window will stay open. The most typical problem is that the sash cord or chain that connects the weight and pulley needs to be replaced. Make sure the size of the new cord or chain is the same as the one being replaced. Size number 7 or 8 cord is most typical for domestic windows. Weights can be difficult to replace, so try to salvage them. There is a panel on the

Replacement pulleys can be difficult to find, so attempt to salvage existing pulleys. Try first to lubricate it in place with a "pinpoint" oiler (an aerosol with extension tube). If paint is heavily caked on the pulley, carefully remove it and soak it in a solution of lye. Straighten dents with pliers, and then oil the pulley and replace it.

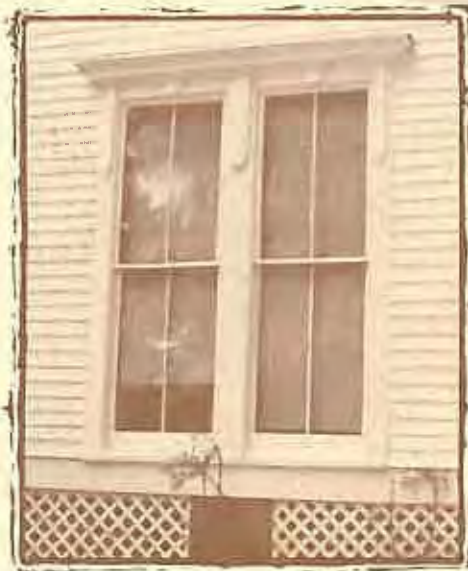
This pair of two over two double hung sash windows have been nicely restored, and are typical of late nineteenth century buildings in Tallahassee.

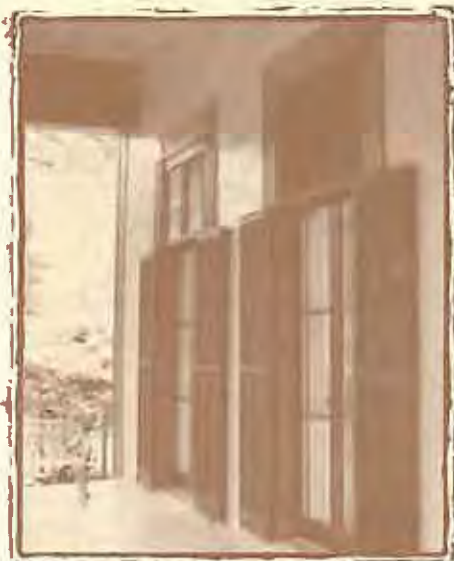
The historic working shutters are an important feature of the Brokaw-McDougall House.

Some of Tallahassee's historic buildings had working shutters. These shutters should be retained when possible. Avoid replacing them with decorative shutters that are not the right proportion for the building.

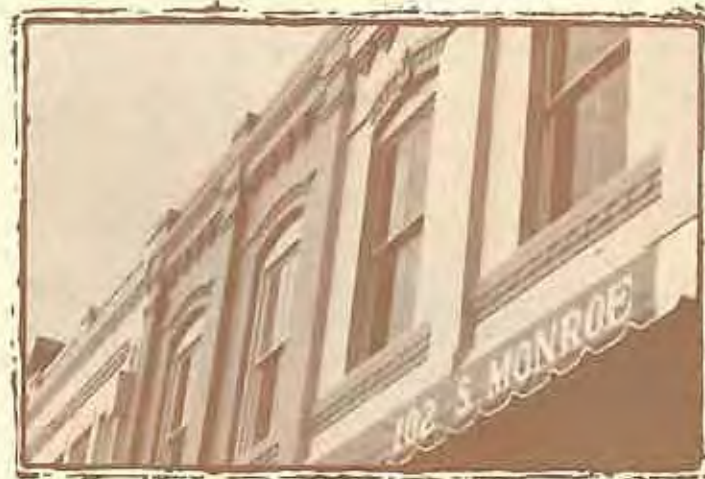
APPROPRIATE
The details on the second floor of this commercial building have been preserved, including brick corbelling, window openings, and pilasters.

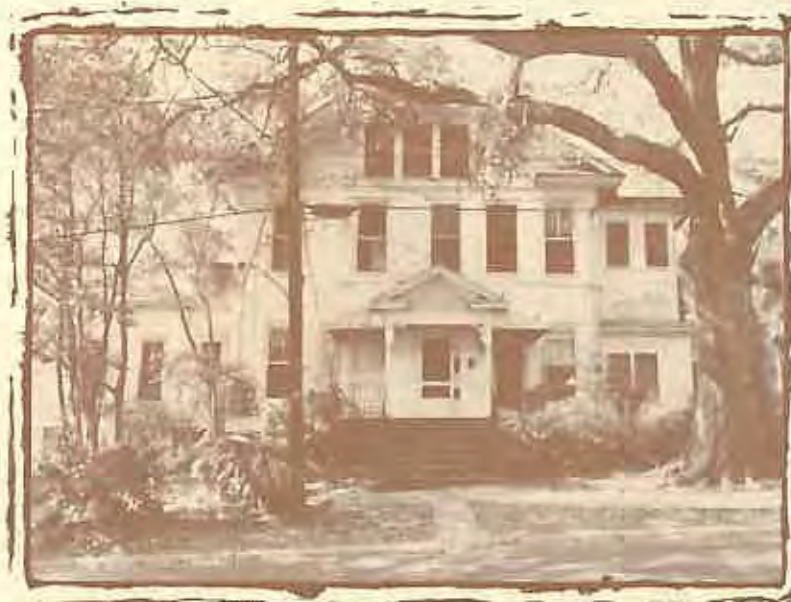
INAPPROPRIATE
Through insensitive additions and asbestos siding, many significant details of this building have been obscured.

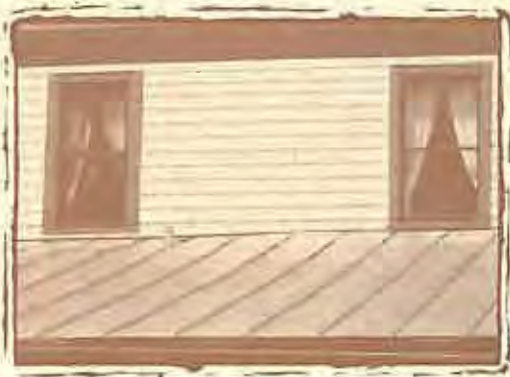
APPROPRIATE
Standing seam metal is a common roofing material in Tallahassee, and should be replaced in kind when necessary.

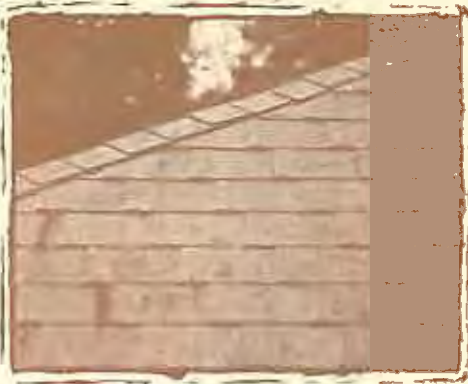
APPROPRIATE
This asbestos shingle roof adds texture to the building.

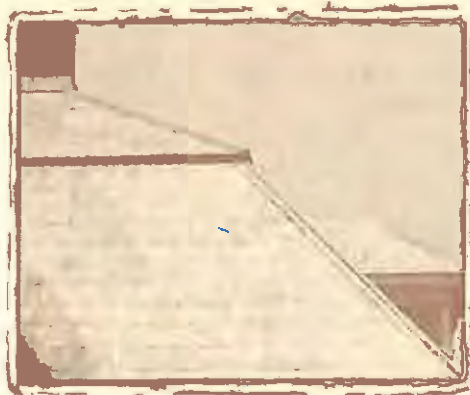
APPROPRIATE
This type of asbestos shingle was common in the early twentieth century. Non-asbestos shingles matching these historic shingles in appearance are available and would be the most appropriate replacement.

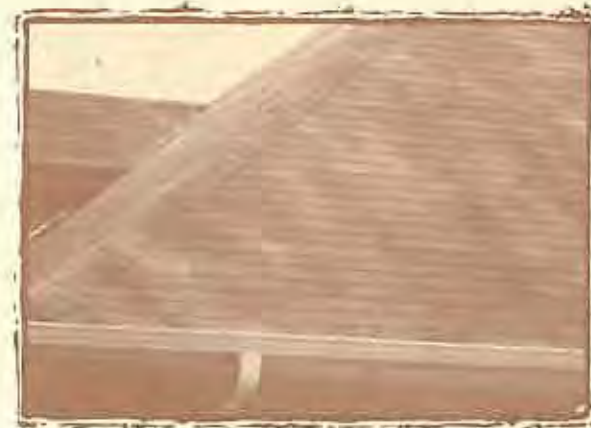
APPROPRIATE
This non-historic roof material is an acceptable alternative if the original roof cannot be repaired, if replacement in-kind is not feasible, or if it is replacing a similar non-historic material.

Composition roofing shingles are an acceptable replacement roofing material. They should complement the historic roof through shingle shape, color, and texture.

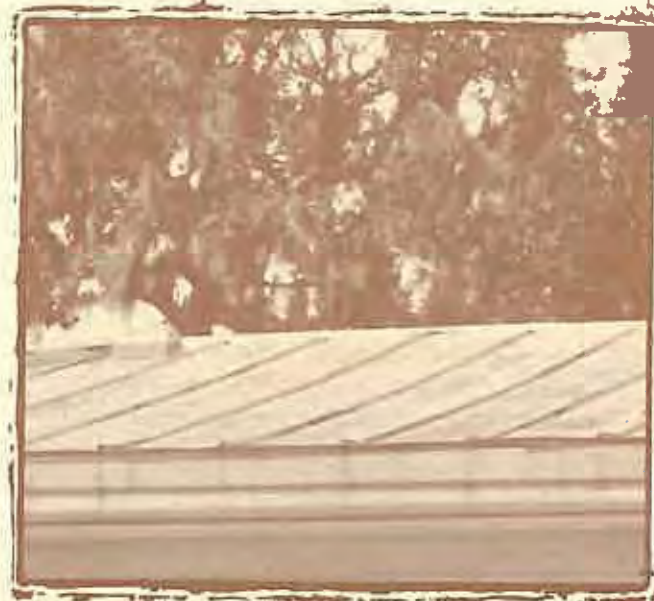
APPROPRIATE
This vent is unobtrusive and provides much needed ventilation for the attic.

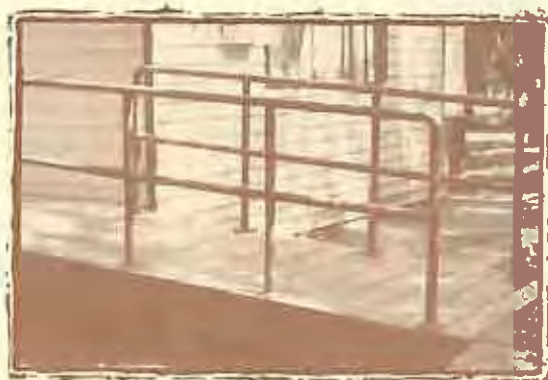
APPROPRIATE
Access to this historic building is facilitated by a ramp placed at the rear of the building and designed to be compatible with the historic structure.

When a residential building is converted to commercial use, sometimes it is necessary to install a fire escape or handicapped accessibility ramp. These additions should be designed in a way that preserve the building's character defining features, and do not detract from the overall character of the building. When possible, add these features to the side or rear of the building so they are close to the parking lot and away from public view. Do not attempt to make them look historic by using elaborate railings or trim. Rather, design them to be as visually unobtrusive as possible.

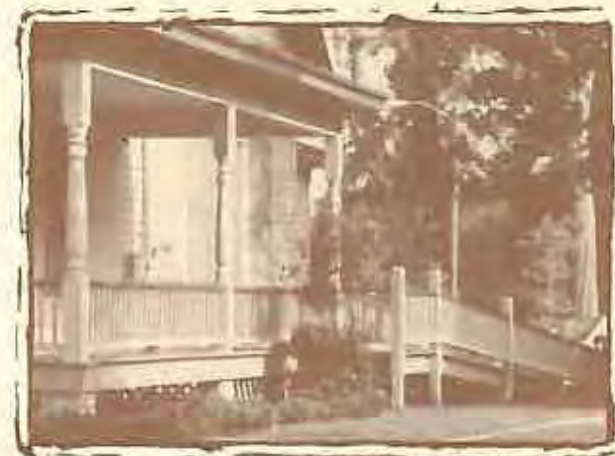
INAPPROPRIATE
This ramp is incompatible in design. It does not respect the historic character of the property.

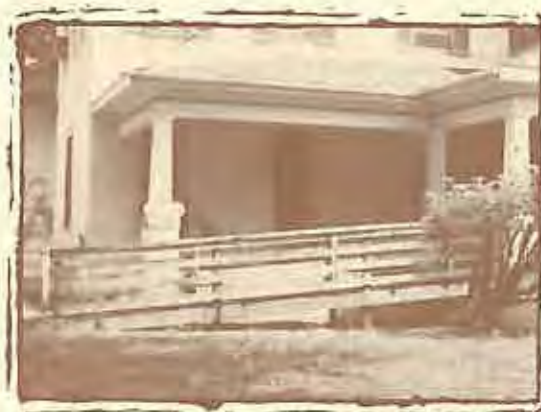
APPROPRIATE
This ramp is to the side of the building and is visually unobtrusive.

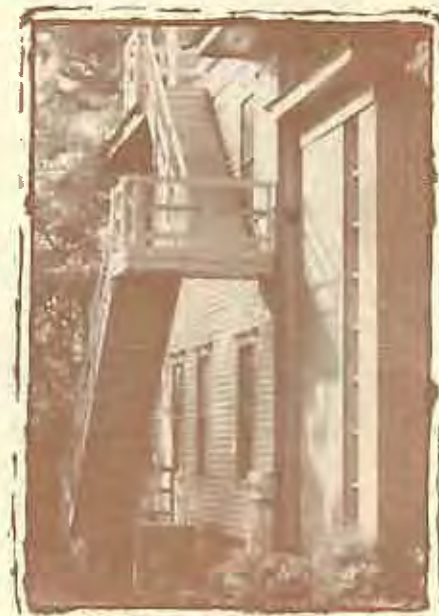
APPROPRIATE
This fire escape is located to the rear of the historic building, away from public view.

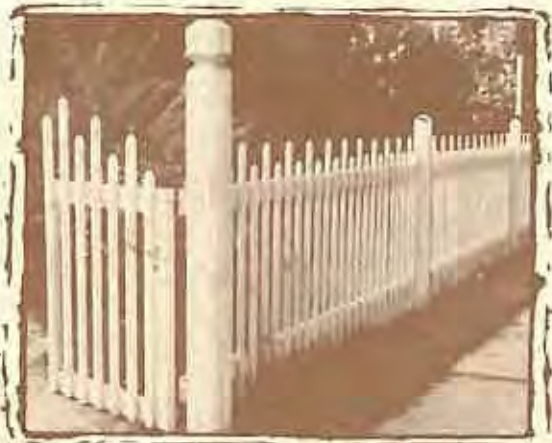
*APPROPRIATE
The character of this fence was replicated when the Chesley House was rehabilitated in 1989.*

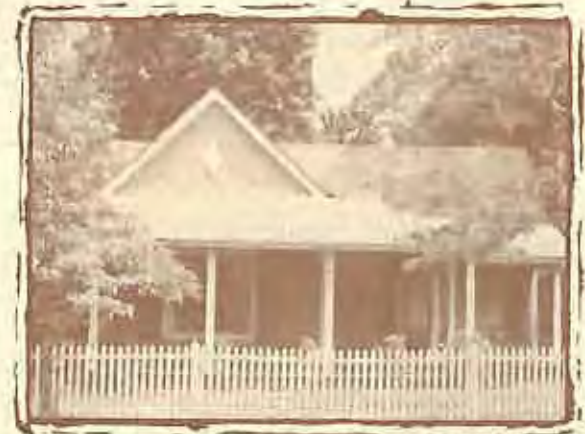
*APPROPRIATE
This non-historic fence illustrates the design elements of historic fences - it is approximately three feet in height and has a transparent quality.*

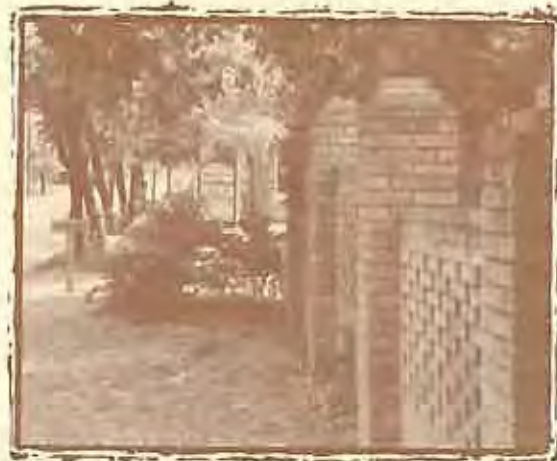
*INAPPROPRIATE
This brick enclosure does not have a transparent quality, and detracts from the character of the district.*
