HISTORIC TALLAHASSEE DESIGN MANUAL

A guide to rehabilitation and new construction
in Tallahassee and Leon County

September 1991

Historic Tallahassee Preservation Board,
Florida Department of State
& Tallahassee-Leon County Architectural Review Board

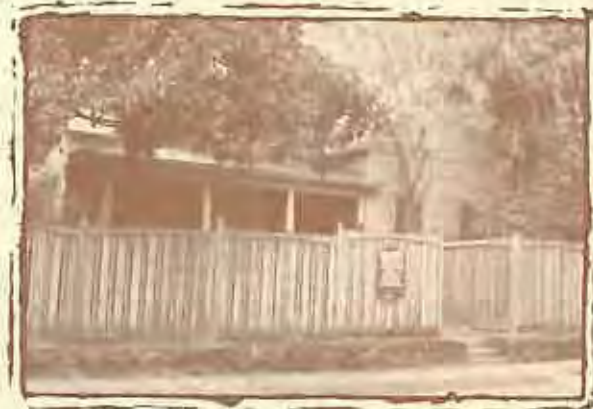
*INAPPROPRIATE
Although of wood, this fence is not transparent and is too high, blocking the view of the building from the district.*

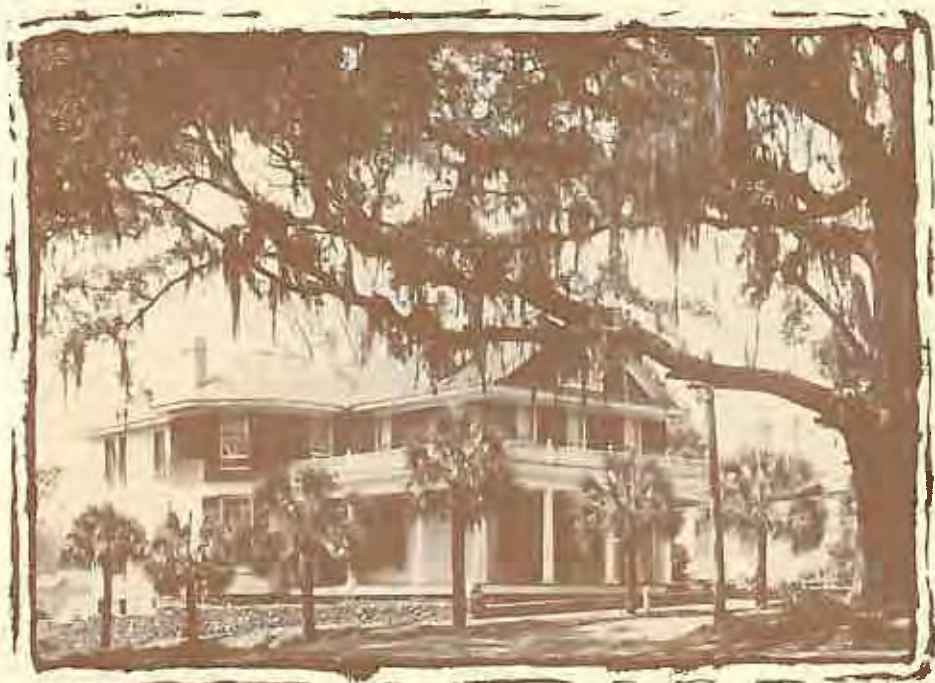
This turn of the century photograph of the Chittenden House at 323 East Park Avenue shows the rock wall which still exists today.

Retaining Walls - A few historic properties downtown have rubble rock or brick retaining walls that contribute to the historic character of the property and should be preserved. The rubble rock walls are comprised of a mixture of rock fragments and concrete, and are an attractive and informal landscape feature. Brick retaining walls are particularly appropriate for brick bungalow and period revival buildings.

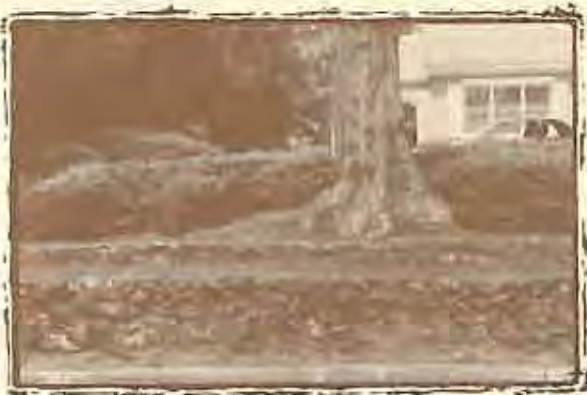
This rubble rock wall should be preserved.

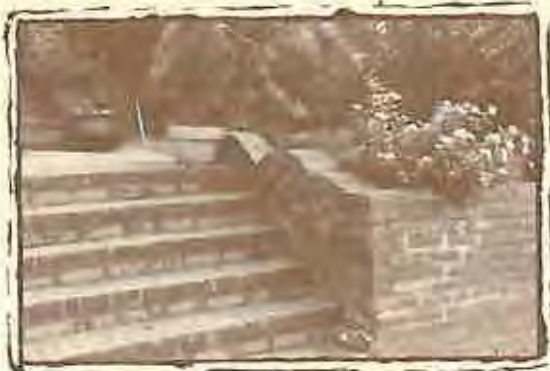
This brick retaining wall is compatible with the historic brick building.

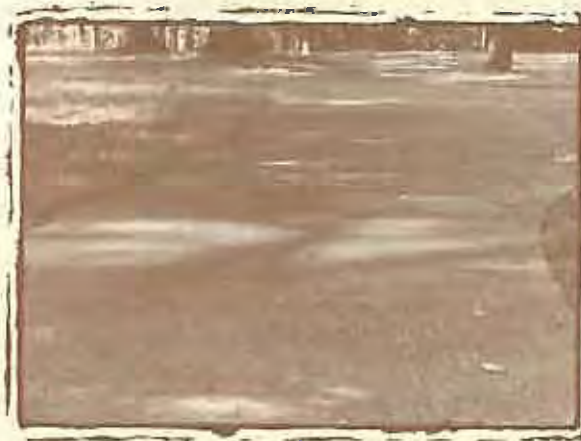
APPROPRIATE
Exposed aggregate paving is a compatible material within the historic district.

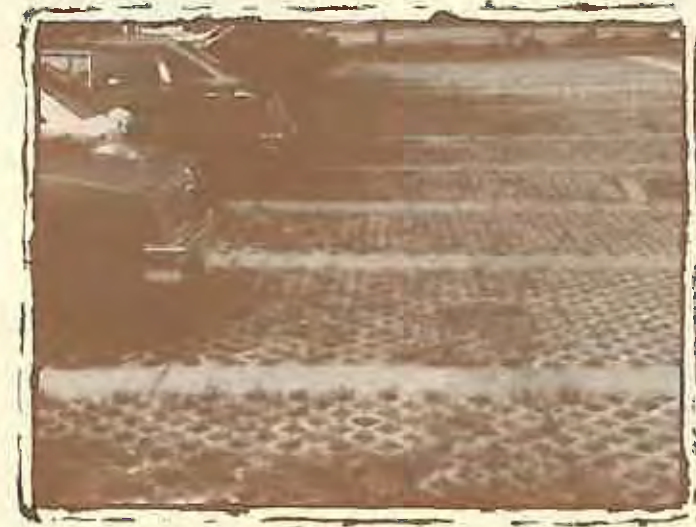
APPROPRIATE
The use of perforated pavers for parking surfaces is encouraged.

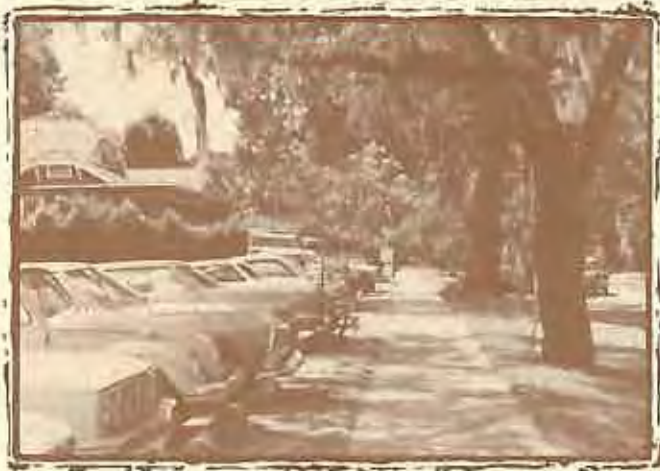
INAPPROPRIATE
This parking lot is not screened with either vegetation or fencing, and has a negative effect on the historic area.

Parking should be away from public view when possible. Generally, it should be located in rear yard spaces, and not extend beyond the front setback line of historic buildings. Plant materials, fences and other buffers should be used to screen parking. Retain significant historic vegetation, and avoid large expanses of impervious surface.

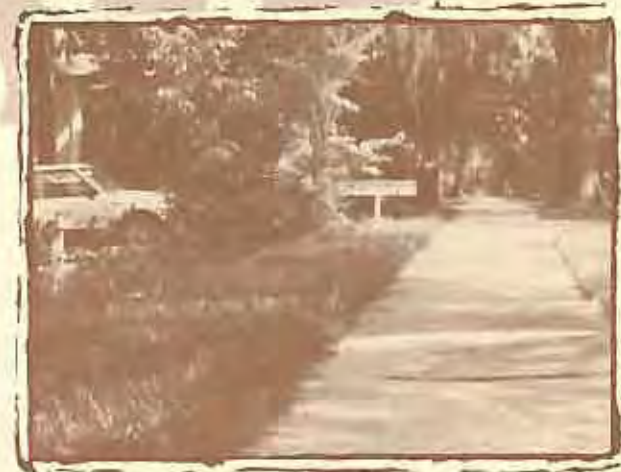
APPROPRIATE
This parking lot uses vegetation as a screen. However, denser vegetation would be more appropriate.

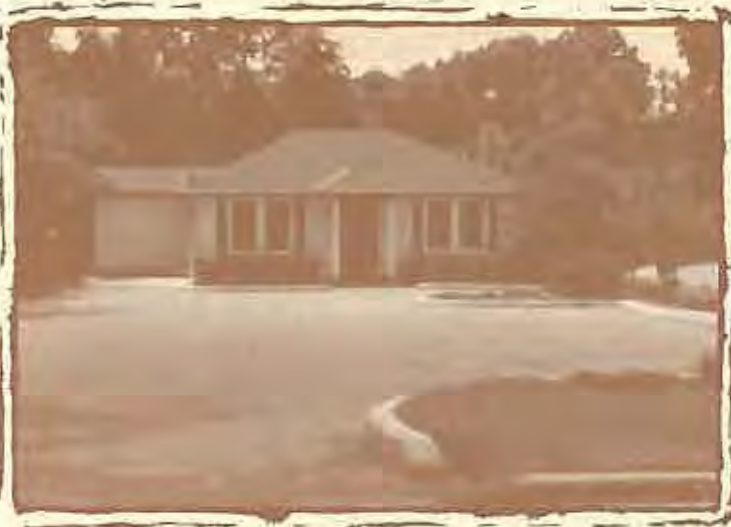
INAPPROPRIATE
This parking area is in front of a historic building, and detracts from the property and area.

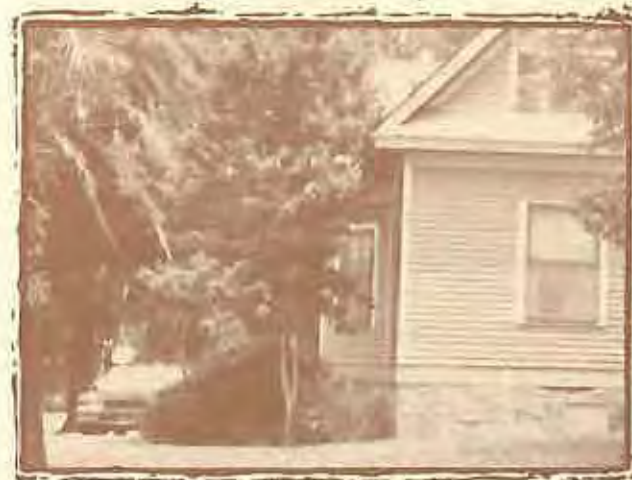
APPROPRIATE
The parking is to the rear of this historic building, and is well screened from public view.

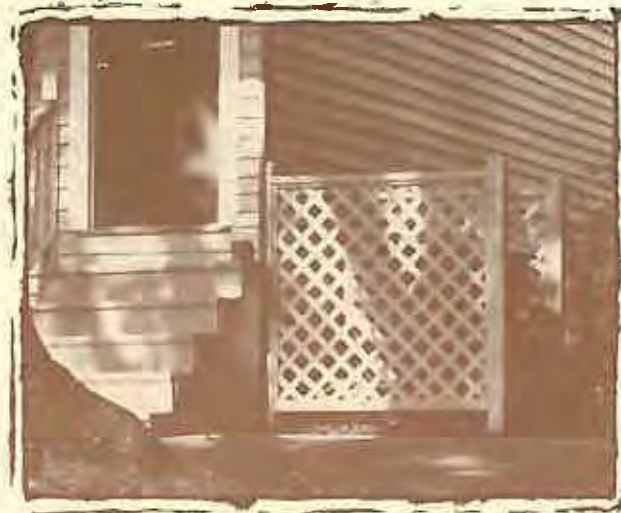
*APPROPRIATE
This lattice draws
from an
architectural feature
of the building and is
appropriate to screen
air conditioning
units, trash
receptacles and the
like.*

Mechanical Systems - Mechanical equipment, such as heating and air conditioning units, or other utilitarian features such as trash receptacles or utility meters, should be screened from view using appropriate fencing or vegetation. Draw

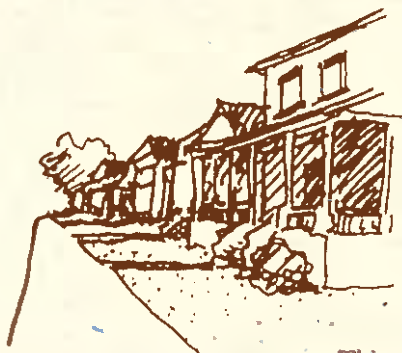
This shows typical residential setback patterns.

Building orientation refers to the directional placement of the building on the site, while setback refers to how far back the building is from the street and adjacent structures. Typically, historic areas had strong predominant orientations and setbacks.

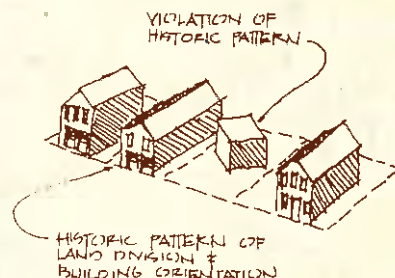
The historic building orientation and setback have been violated, which upsets the rhythm of the streetscape.

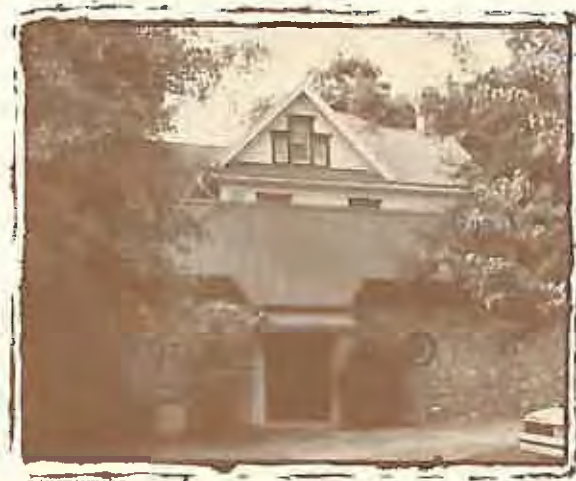
INAPPROPRIATE

This addition to a historic building is clearly incompatible in terms of its massing, scale, material, rhythm and placement on the site.

If an addition is being constructed, generally it should not be added to the main historic facade of the building. If possible, locate it away from the principal public view, possibly to the rear of the building. Respect the proportions of the building to which it is being added, so the addition does not dominate its historic environment. Do not obscure character-defining features of the historic building with the addition.

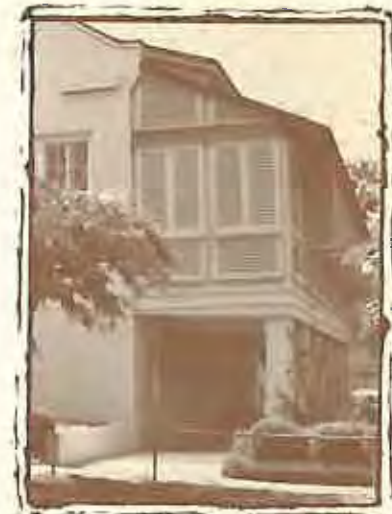
APPROPRIATE

This addition was added to the rear of the Randall-Lewis House at 424 North Calhoun Street, and is visible from the public right of way. It is compatible to the historic building in terms of massing, scale, and design, and at the same time is clearly an addition.

were constructed on the building, and thus provide guidance for the location of new additions. However, the new addition should not be designed to look historic. It is inappropriate to imitate a historic style, or use the same roof line, wall plane, or historic details in an attempt to make the addition look like it was originally a part of the building. The addition may be contemporary, or may incorporate design motifs that tie it in to the historic building. No matter what its design, it should be of quality workmanship and materials. The addition should be designed to be clearly an addition, and should

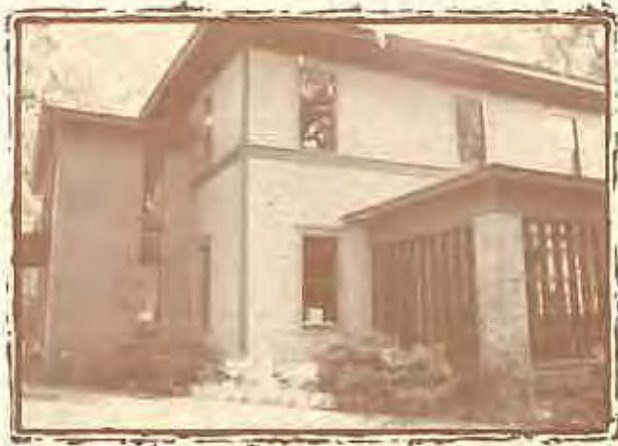
APPROPRIATE
This addition (at left) to the west facade of the Murrow House at 500 Miccosukee Road is clearly contemporary, yet is compatible with the historic building. It is not located on a principal historic facade of the building. In a contemporary manner it interprets historic elements of the building such as brick piers and lattice work.

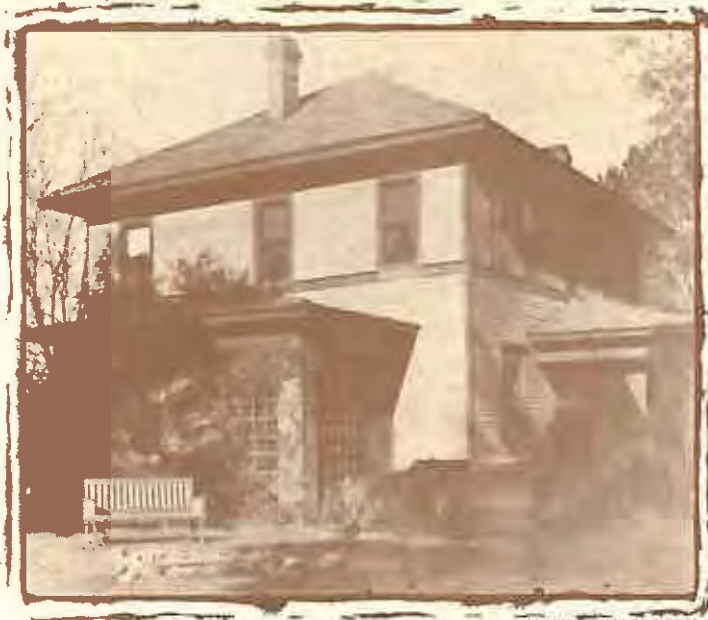
This historic photograph of the east and south facades of Murrow House provided guidance for use of the brick piers and lattice in the contemporary addition.

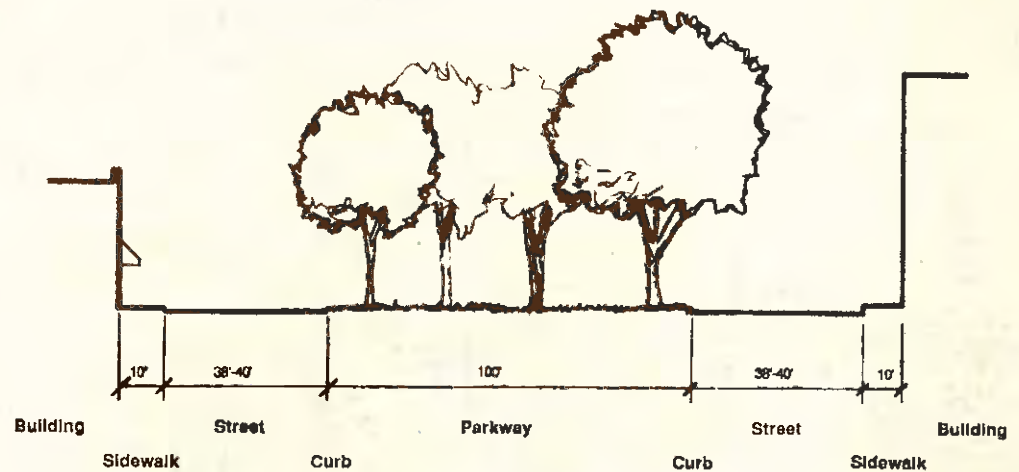
*Cross Section -
Sub-area A of the
Park Avenue Historic
District*

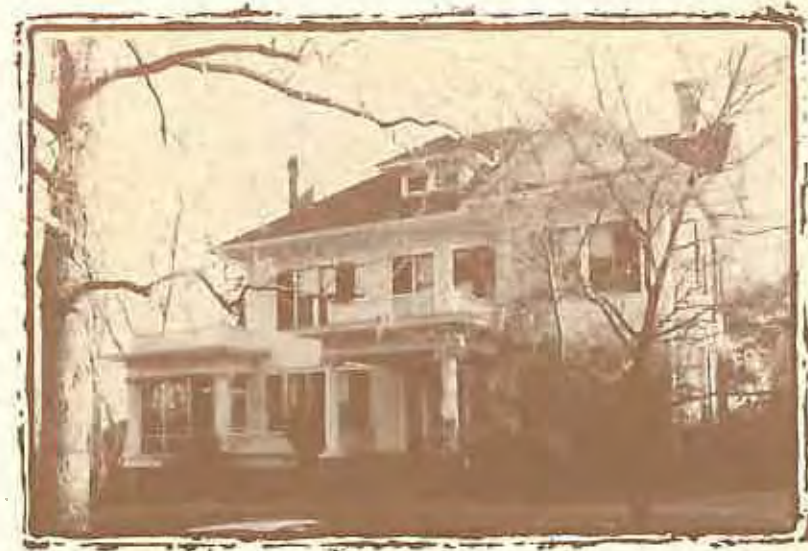
Constructed in 1913, the Lively House at 403 East Park Avenue contributes to the historic streetscape.

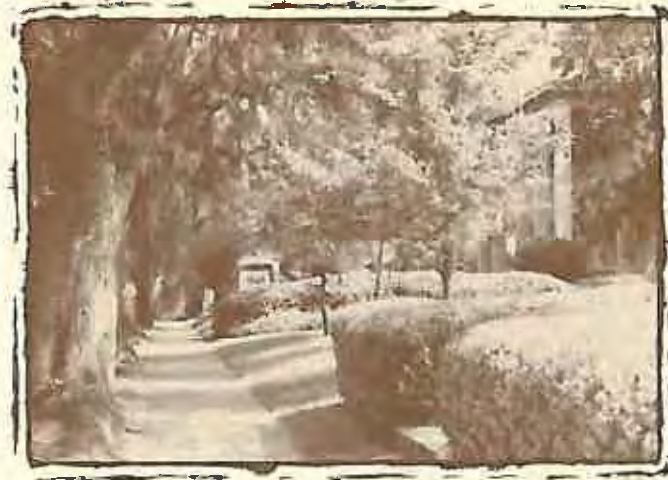
The canopy of live oak trees are a distinctive feature in the Calhoun Street District.

- ❖ Alterations, additions, and new construction should respect the historic character of the area in scale, massing, and other character-defining features.
- ❖ To soften the visual impact of existing parking lots, a minimum 10 foot wide landscaped front setback from sidewalk, or 12 foot setback from curb if there is no sidewalk, is recommended.
- ❖ Fences may be used as an alternative to buffer parking lots.
- ❖ Parking lots behind buildings should not extend in front of the front facade line of the building. In addition, a 6 foot minimum landscaped side yard is recommended.
- ❖ Access to parking lots should be through historic drives, if possible. In no case should street trees be removed to accommodate access.
- ❖ Continue with new plantings of live oaks to ensure the continuance of the canopy that makes Calhoun Street distinctive.

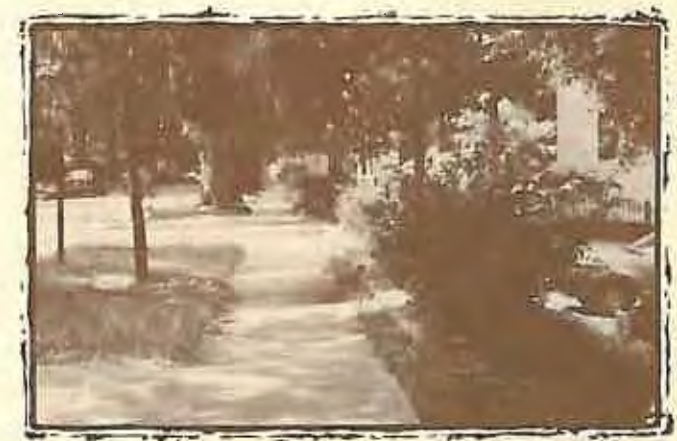
Buffering of parking lots is a concern in the Calhoun Street District.

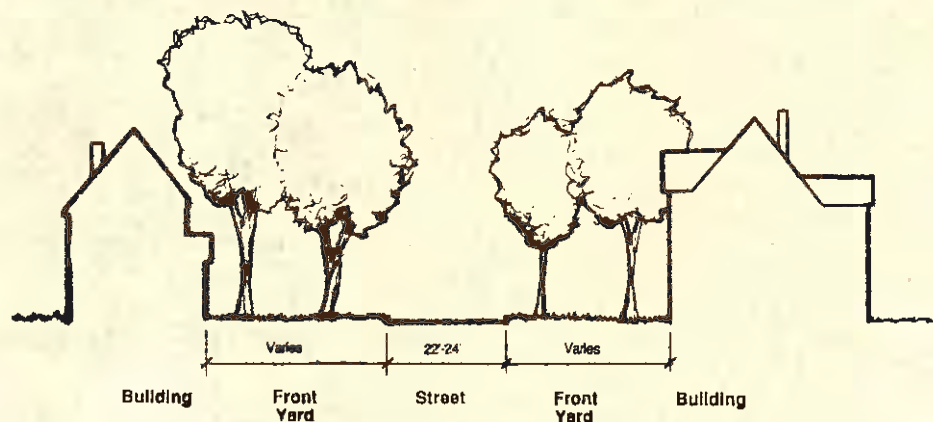
*Cross Section -
Magnolia Heights
Historic District*

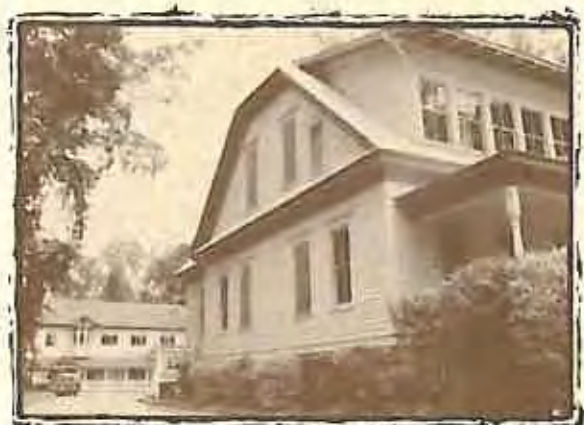
These new office buildings are appropriately located behind historic buildings, and do not detract from the historic character of the streetscape.

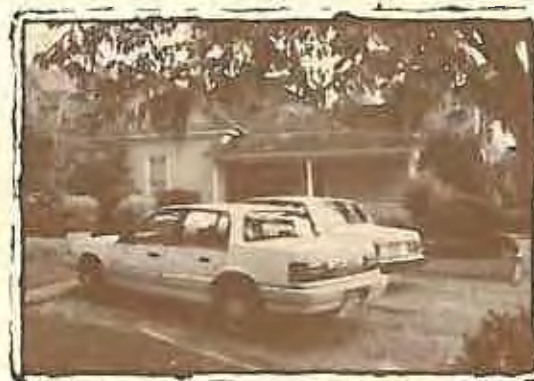
A number of historic buildings have parking lots in the front yard setback which detract from the character of the district.

- ❖ No parking should be allowed in the front yard setback or allowed to encroach in front of the front facade building line of neighboring buildings where possible. When required parking cannot be accommodated in the side or rear yards, a front setback of at least 10 feet behind the right-of-way will provide for some buffering of the parking.

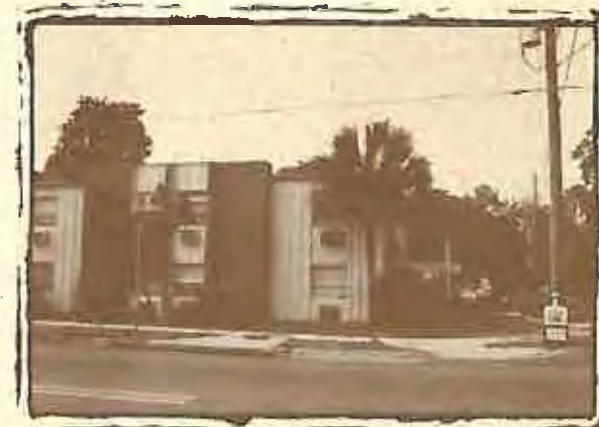
The design of some apartment buildings detracts from the character of the district.
